INVESTIGATIONS OF AIR-COOLED TURBINE ROTORS FOR
TURBOJET ENGINES

II - MECHANICAL DESIGN, STRESS ANALYSIS, AND
BURST TEST OF MODIFIED J33 SPLIT-DISK ROTOR

By Richard H. Kemp and Merland L. Moseson

Lewis Flight Propulsion Laboratory
Cleveland, Ohio

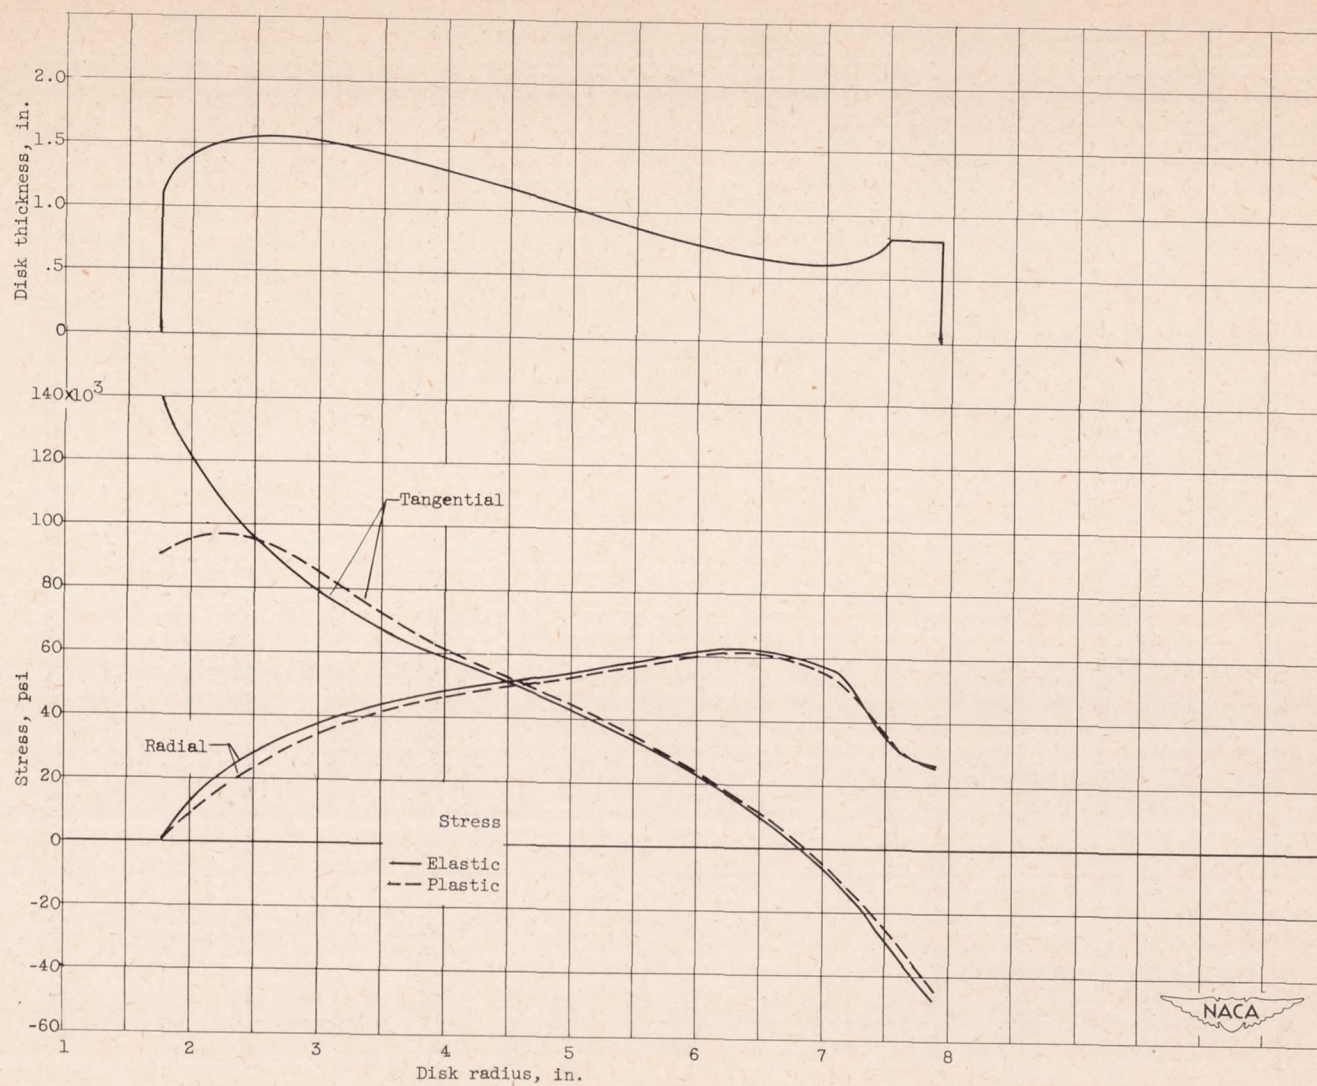
Figure 10. - Effective profile and elastic and plastic stresses at 12,650 rpm for split rotor with assumed radial-temperature gradient.

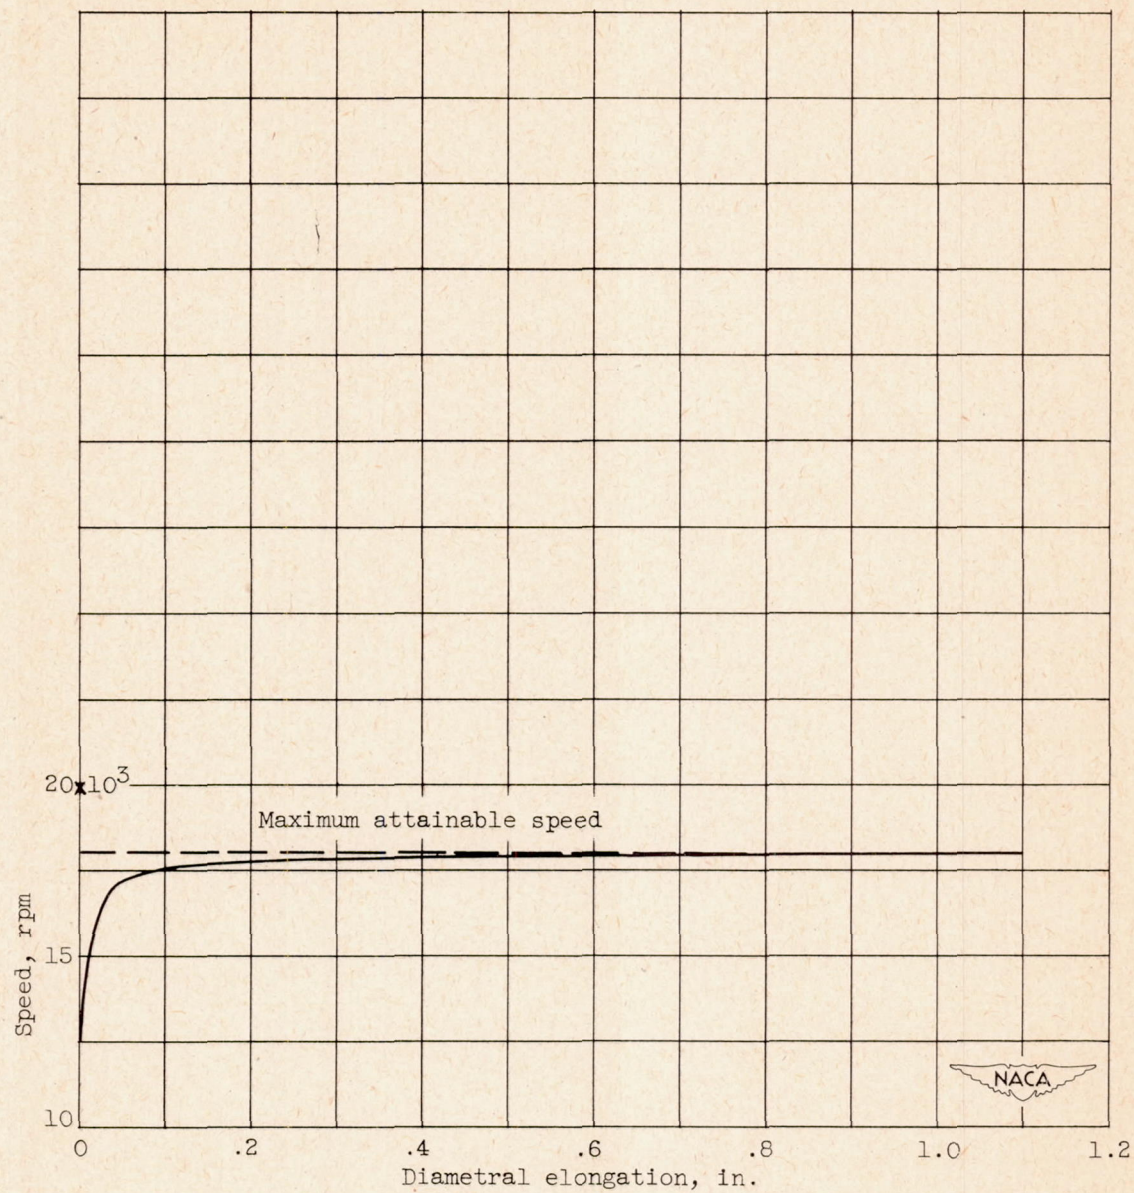
Determination of theoretical burst speed. - As described previously, the elongation of the disk was computed at successively higher speeds until sufficient points were obtained for the plot shown in figure 11. The curve reaches a maximum at a speed of 17,900 rpm, which is therefore taken as the maximum attainable speed of the disk. It is apparent that a substantial factor of safety exists since the maximum operating speed is 11,500 rpm.

Figure 11. - Deformation and bursting of air-cooled rotor.

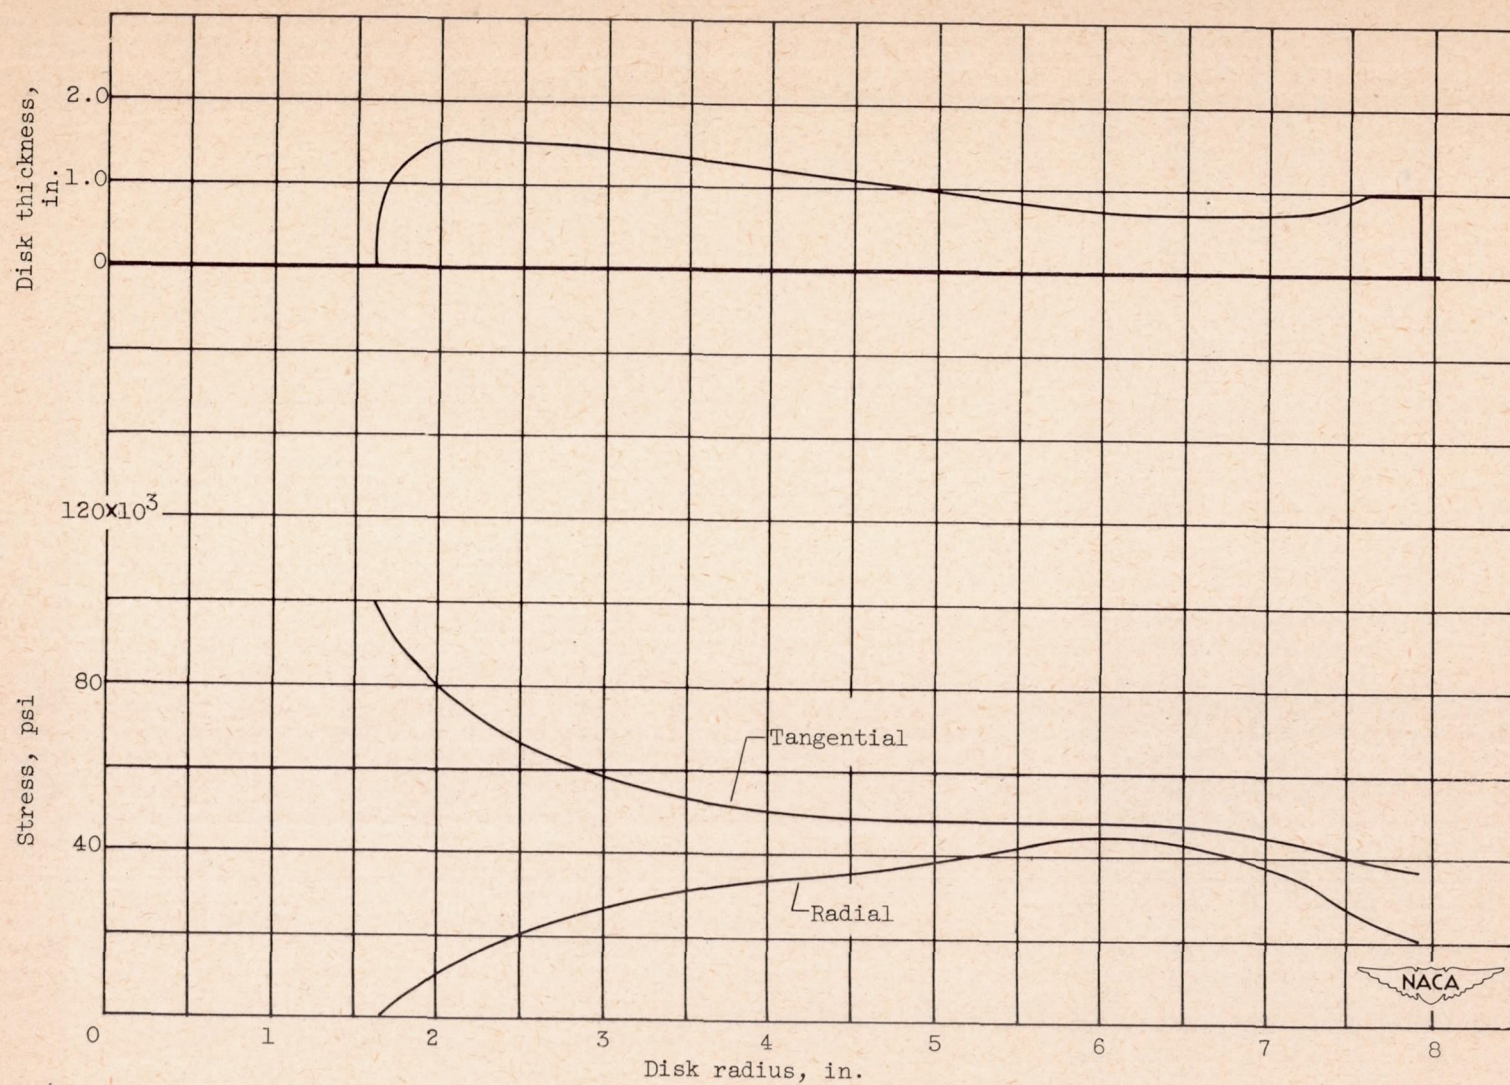
Stress analysis. - A stress analysis of the spin-test rotor was made in a manner similar to that described in the preceding section for the rotor intended for engine operation. The rim loading was calculated to be 21,000 pounds per square inch at 12,650 rpm on the basis of a 150 gram airfoil plus its hollow base and the interrupted portion of the rotor at the rim. This value differs from the rim loading of the engine rotor because of a subsequent change in the design of the blade base. The loading was obtained through the use of ordinary solid blades which were cut to the proper length. The radial and tangential elastic stress curves are shown in figure 12 for 12,650 rpm together with the effective profile. Temperature along the radius was assumed to be constant. The tangential stress at the hole exceeds the elastic limit of the material by a small amount and some plastic flow would be expected giving a minor adjustment of stresses in the immediate vicinity of the hole. A prediction of the burst speed was made in the same manner as described previously and was determined to be 18,500 rpm. Since the actual burst speed is generally found to be 2 to 5 percent below the theoretical value, the rotor would be expected to burst in the range of approximately 17,600 to 18,100 rpm.

Figure 12. - Effective profile and stresses at 12,650 rpm for split rotor used in spin test.

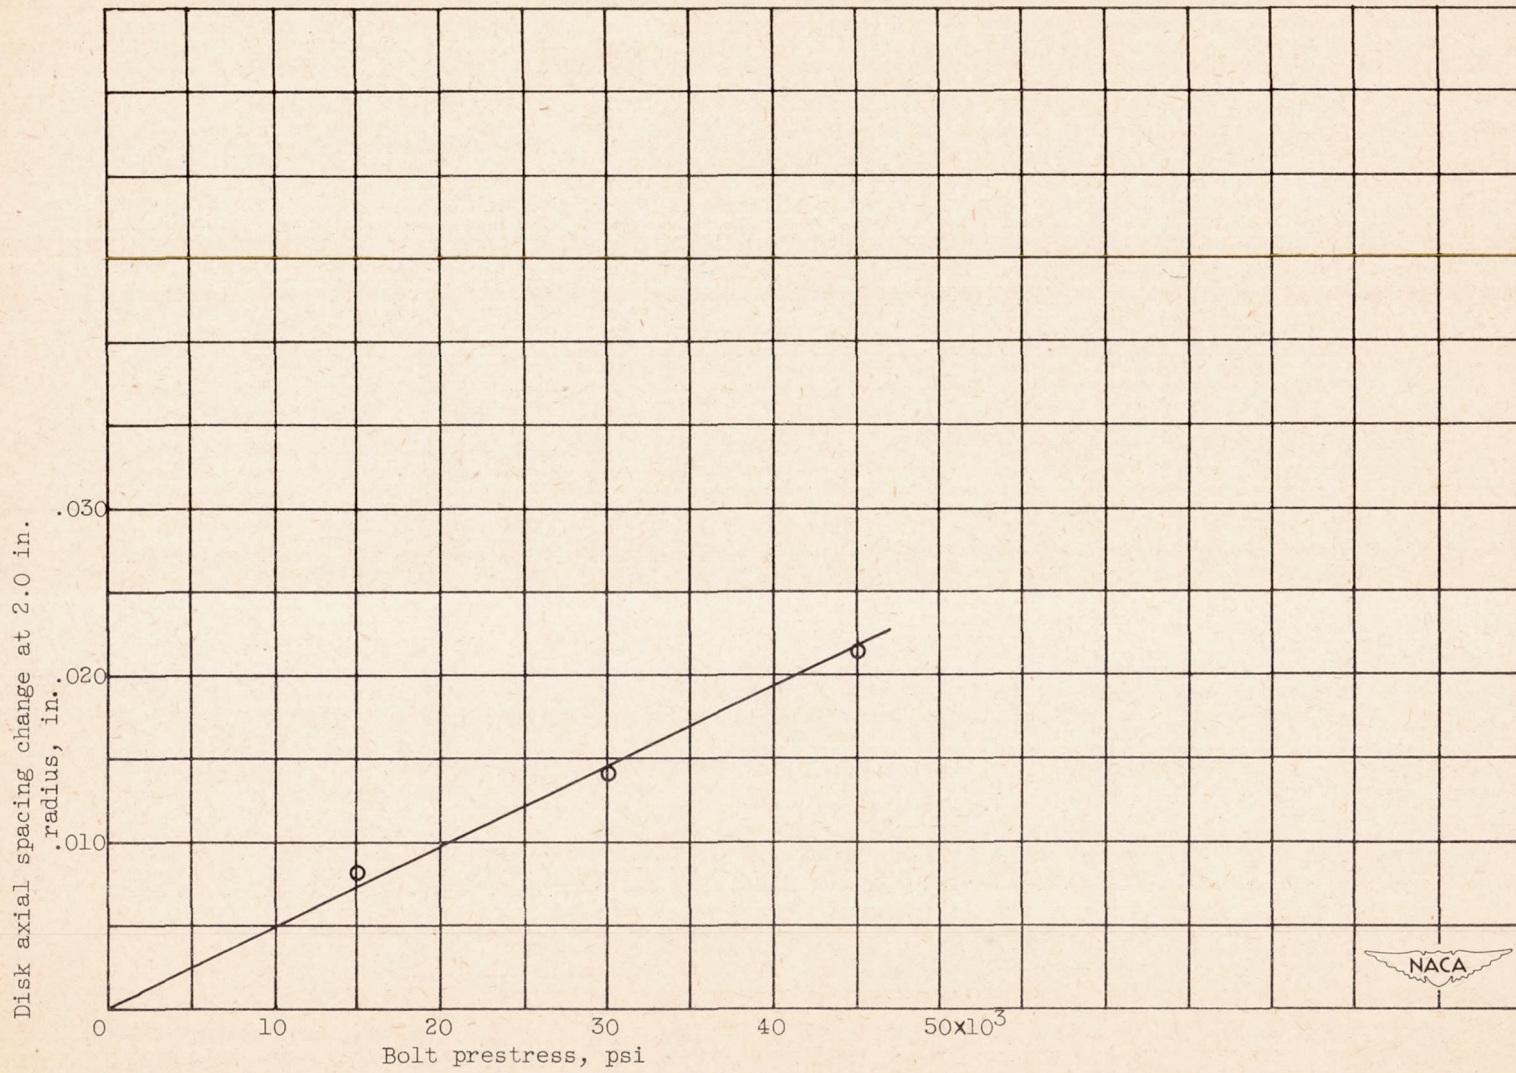
Figure 13. - Relation between bolt prestress and disk axial spacing.

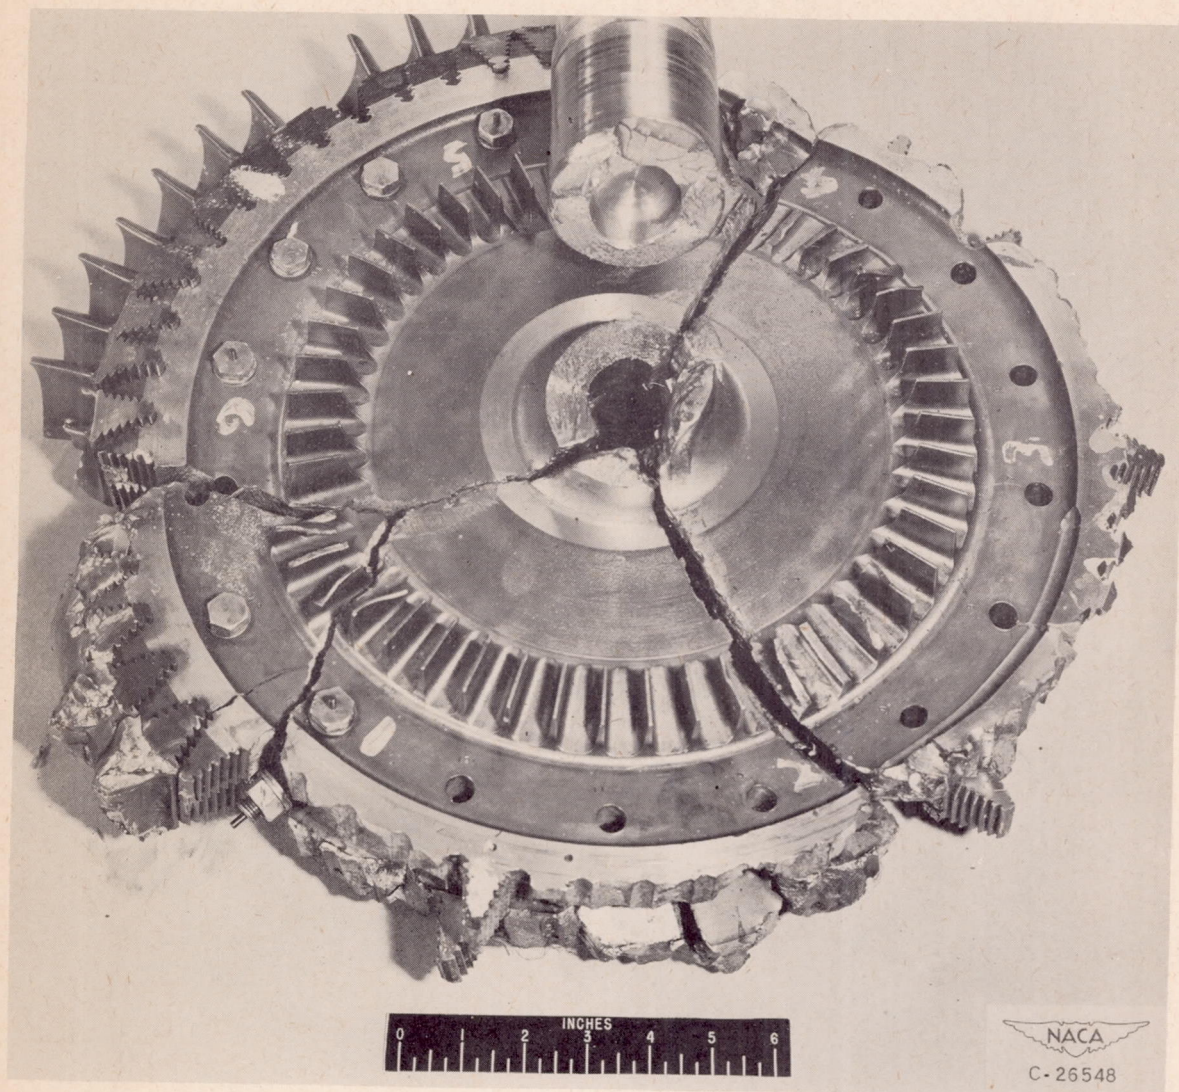
(a) Forward disk fragments and shaft.

After the preliminary spin-test results were obtained, the rotor was spun to destruction, burst occurring at a speed of 17,200 rpm. The actual burst speed, therefore, compared favorably with the predicted range.

In figure 14(a) the forward disk is shown pieced together after the burst, with the shaft shown in the upper portion of the photograph. A view from the rear is presented in figure 14(b) and figure 14(c) shows the remaining fragments of the rear disk which do not appear in figure 14(b). The fracture lines are predominantly radial and no large rim sections were lost because of fracture lines between bolt holes, therefore bolt holes do not constitute a hazard in this design. Some of the radial fracture lines passed through the bolt holes while others did not. Approximately one-third of each of the two disks remained bolted together after the burst as shown in figure 14(b). The shaft fractured in the weld region.

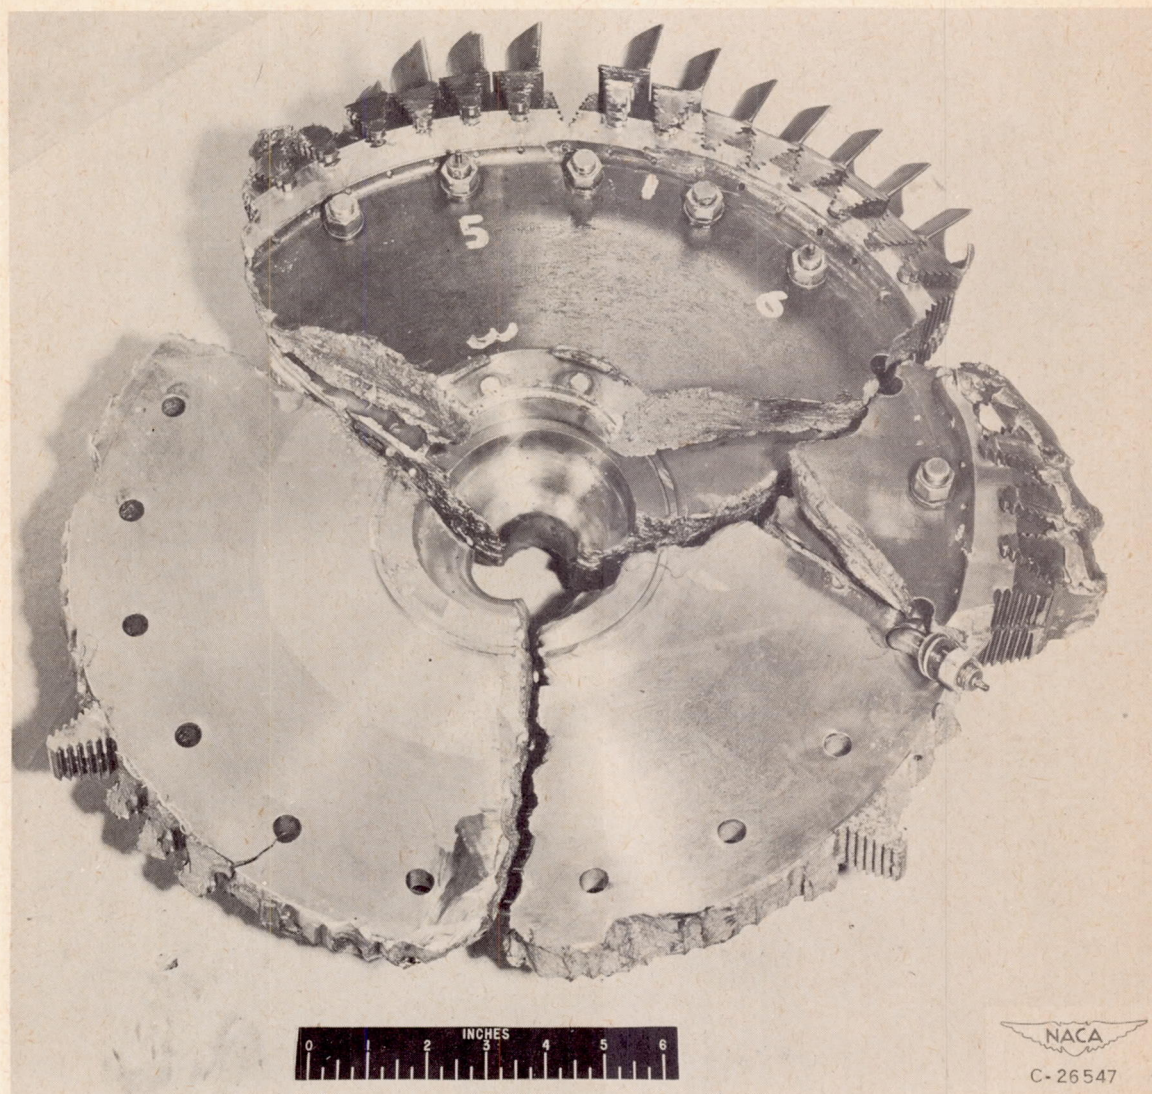
(b) Forward and rear disk fragments viewed from rear side.

Figure 14. - Burst air-cooled rotor.

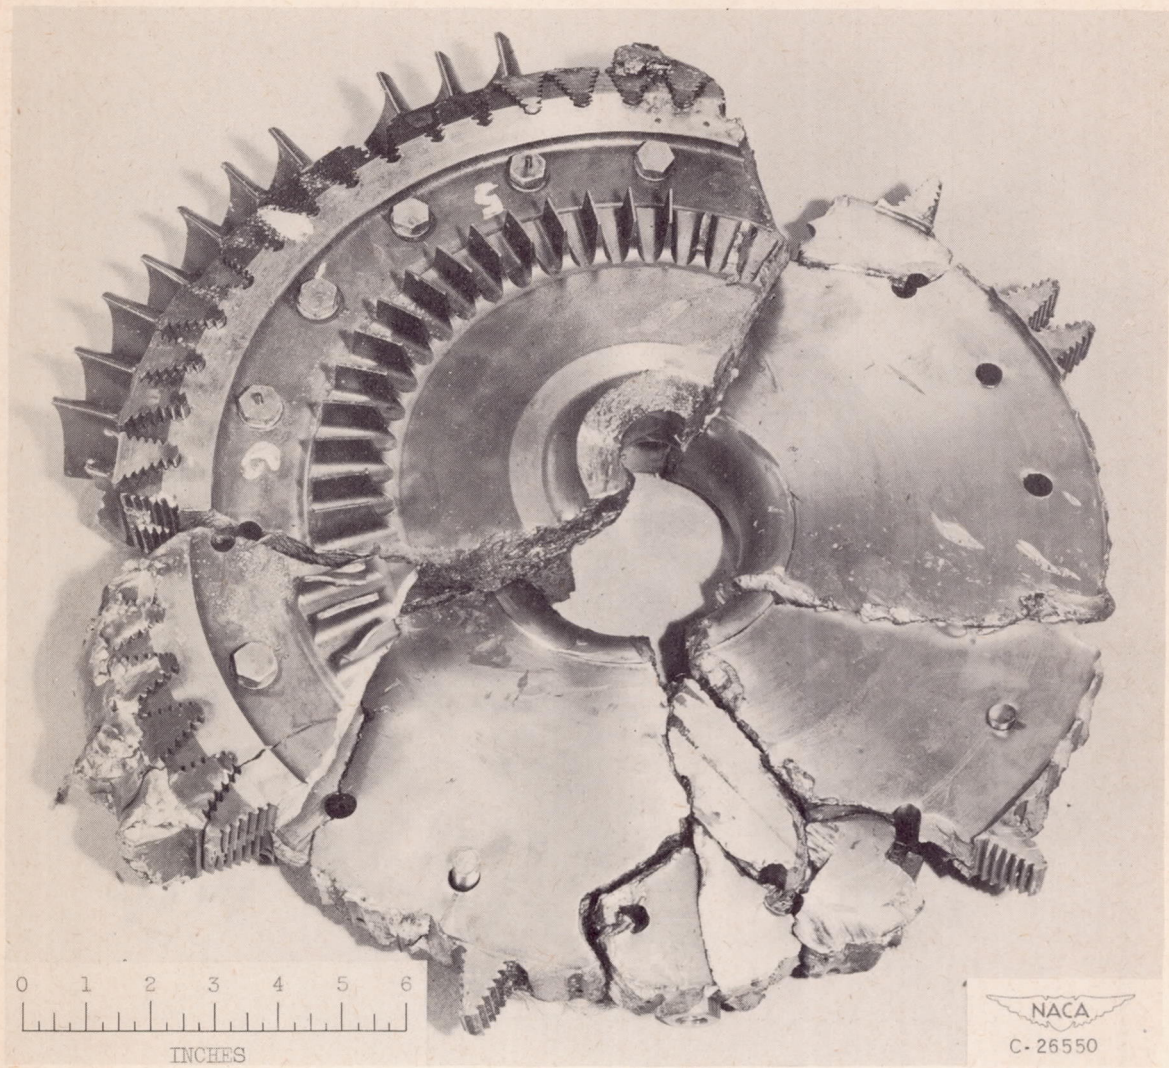
(c) Forward and rear disk fragments viewed from forward side.

Figure 14. - Concluded. Burst air-cooled rotor.

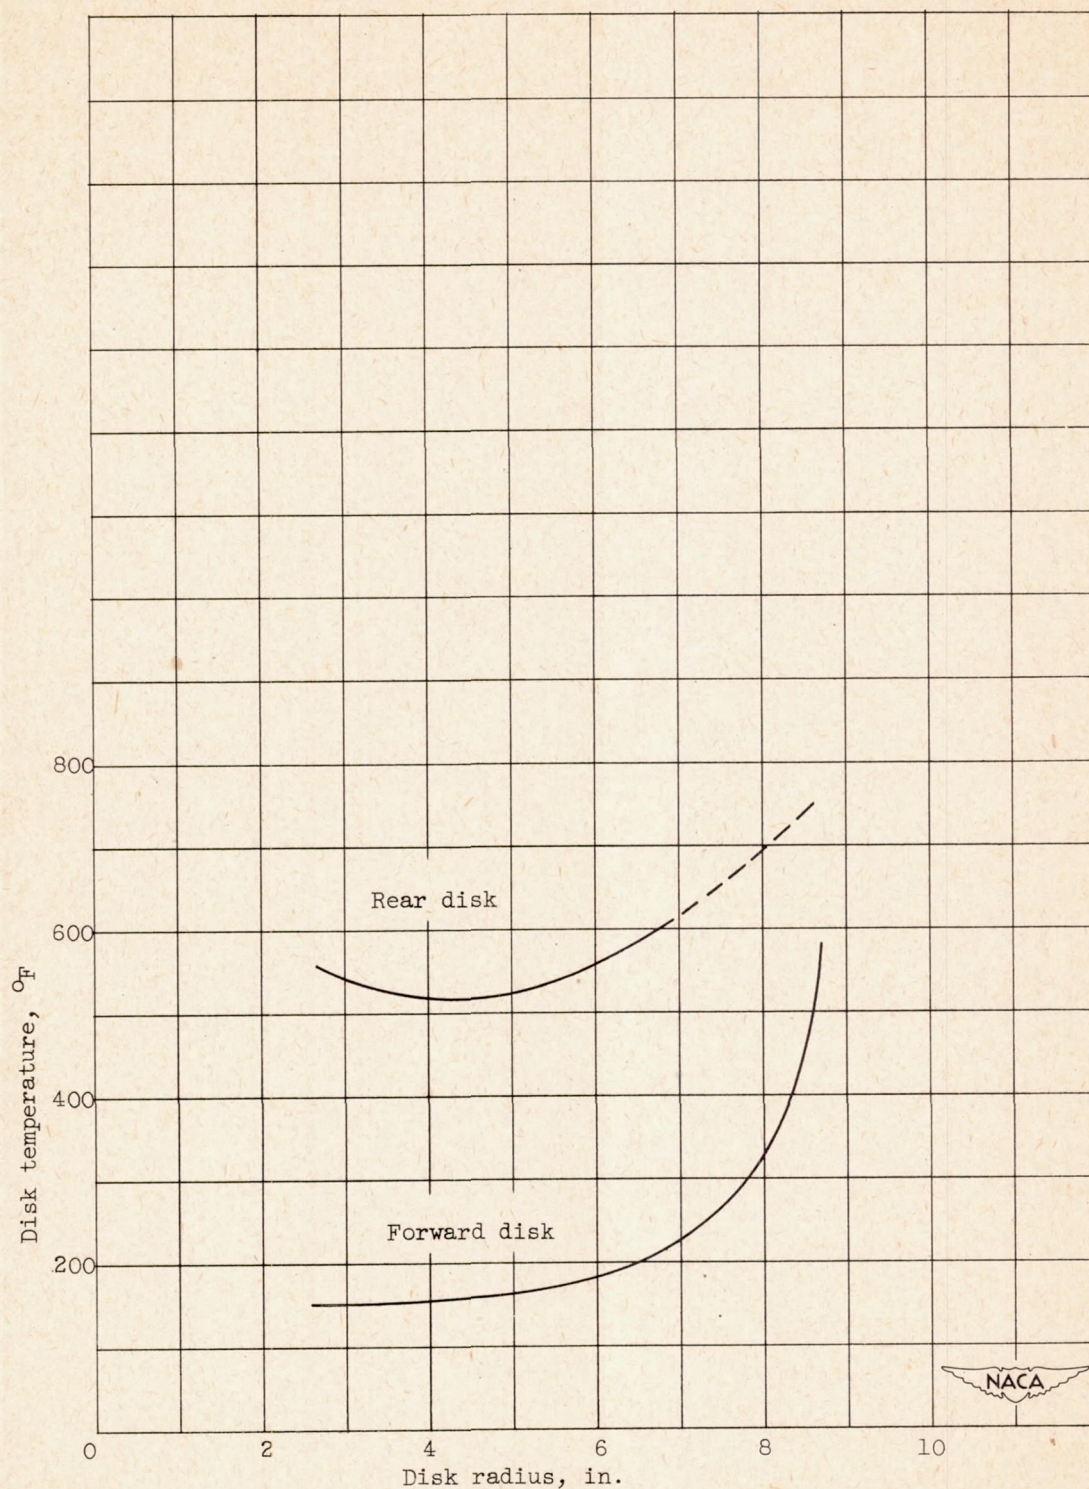
Measured temperature distribution. - In the foregoing analysis, the predicted temperature gradient shown in figure 9 was assumed to apply to both the forward and the rear disks of the split rotor. During operation of the split rotor in a J33 turbojet engine as described in reference 13, the forward disk ran at temperatures substantially lower than the rear disk. The estimated temperature distribution for the two disks at 11,500 rpm, effective gas temperature 1445° F, and effective cooling-air temperature 120° F at a coolant flow ratio of 0.02 is shown in figure 15 which was taken from reference 13. These temperature distributions were estimated from actual measured temperatures at lower speeds. A difference of approximately 375° F exists between the two disks. For the stress analysis of the disk proper, the curves are of interest only up to the 8-inch radius, beyond this point the temperatures are of interest in determining the strength of the blade fastening.

Direct substitution of a noncritical material in blades and disks of the same configuration as the air-cooled split-disk rotor discussed herein was investigated. Stress analysis based on the radial temperature gradients plotted on figure 15 for the forward and rear disks indicated that Timken 17-22A(S) had sufficient strength for this disk application. The same material also exhibited adequate strength when used for the rotor blades during the engine cyclic tests reported in reference 14. A comparison of weights and critical material content between an air-cooled turbine rotor of the same configuration as that reported and the J33 engine is presented in table I. A reduction in total rotor weight of 46.2 percent as indicated in the table would not be likely generally because this air-cooled rotor is compared with an obsolete model non-cooled design which is much heavier than the current production rotor for the same engine. Because reductions up to 98 percent can be accomplished in the critical material content of turbine blades and disks for operation at present gas temperatures of 1600° F to 1700° F, the use of intermediate alloys in conjunction with air cooling could increase these gas temperatures.

Figure 15. - Disk temperature distributions at 11,500 rpm, based on measured temperatures at lower speeds (reference 1). Engine speed, 11,500 rpm; cooling-air flow ratio, 0.02; cooling-air inlet temperature, 120° F; effective gas temperature, 1445° F.

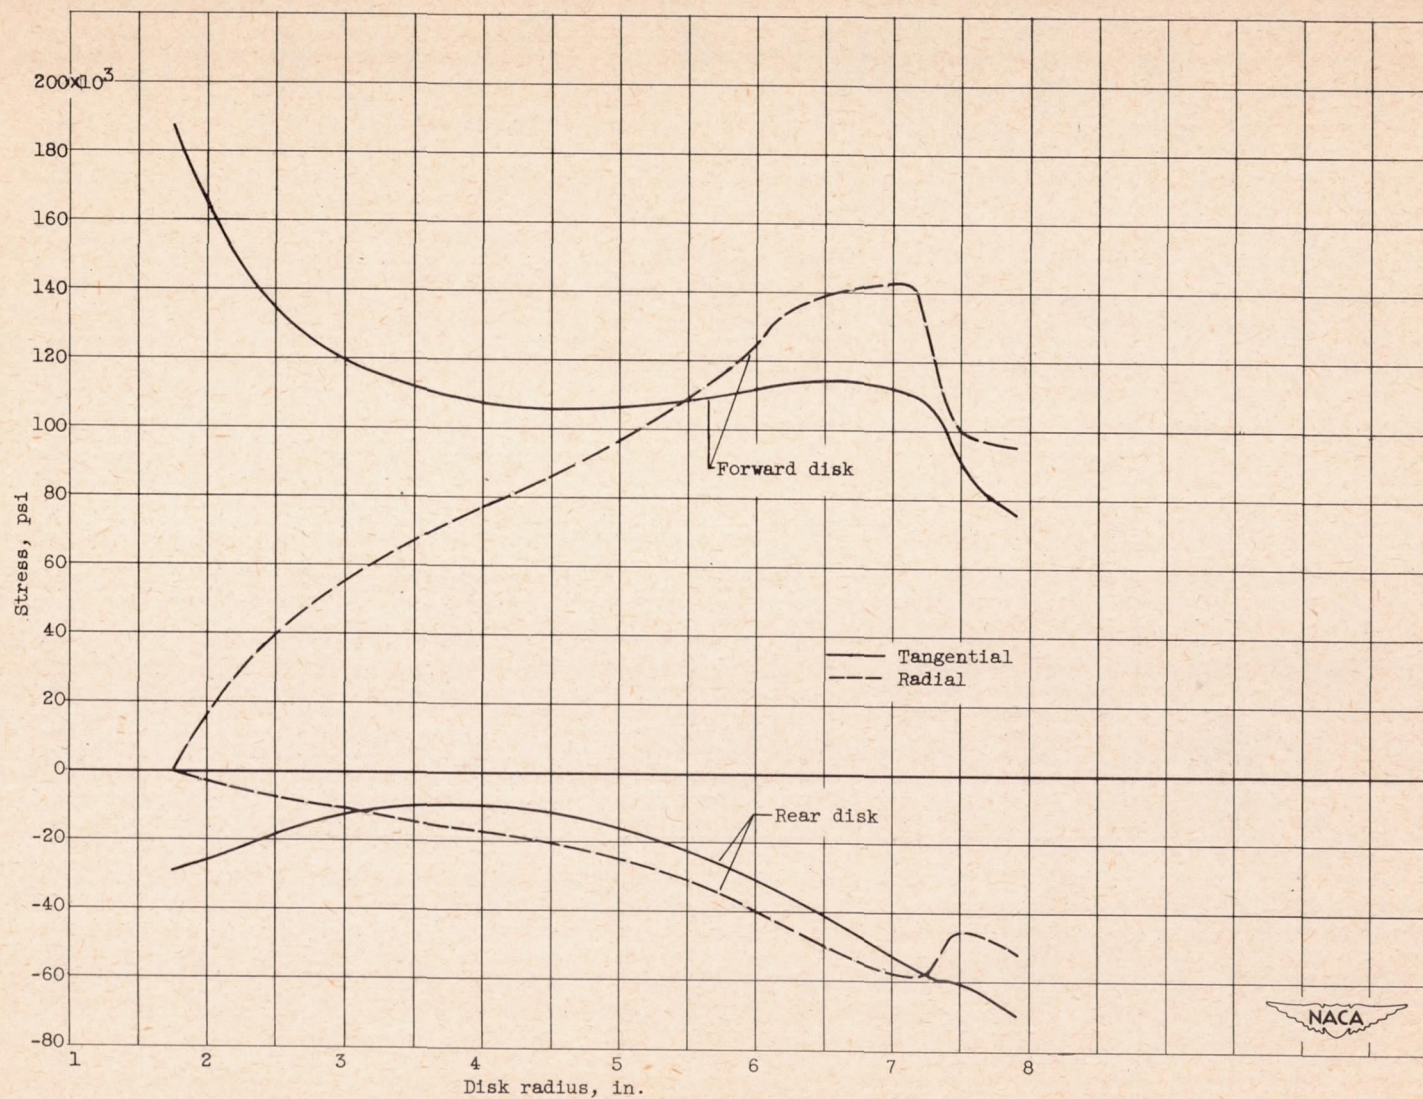
Figure 16. - Elastic stresses for forward and rear disks having dissimilar temperature distributions at 11,500 rpm.

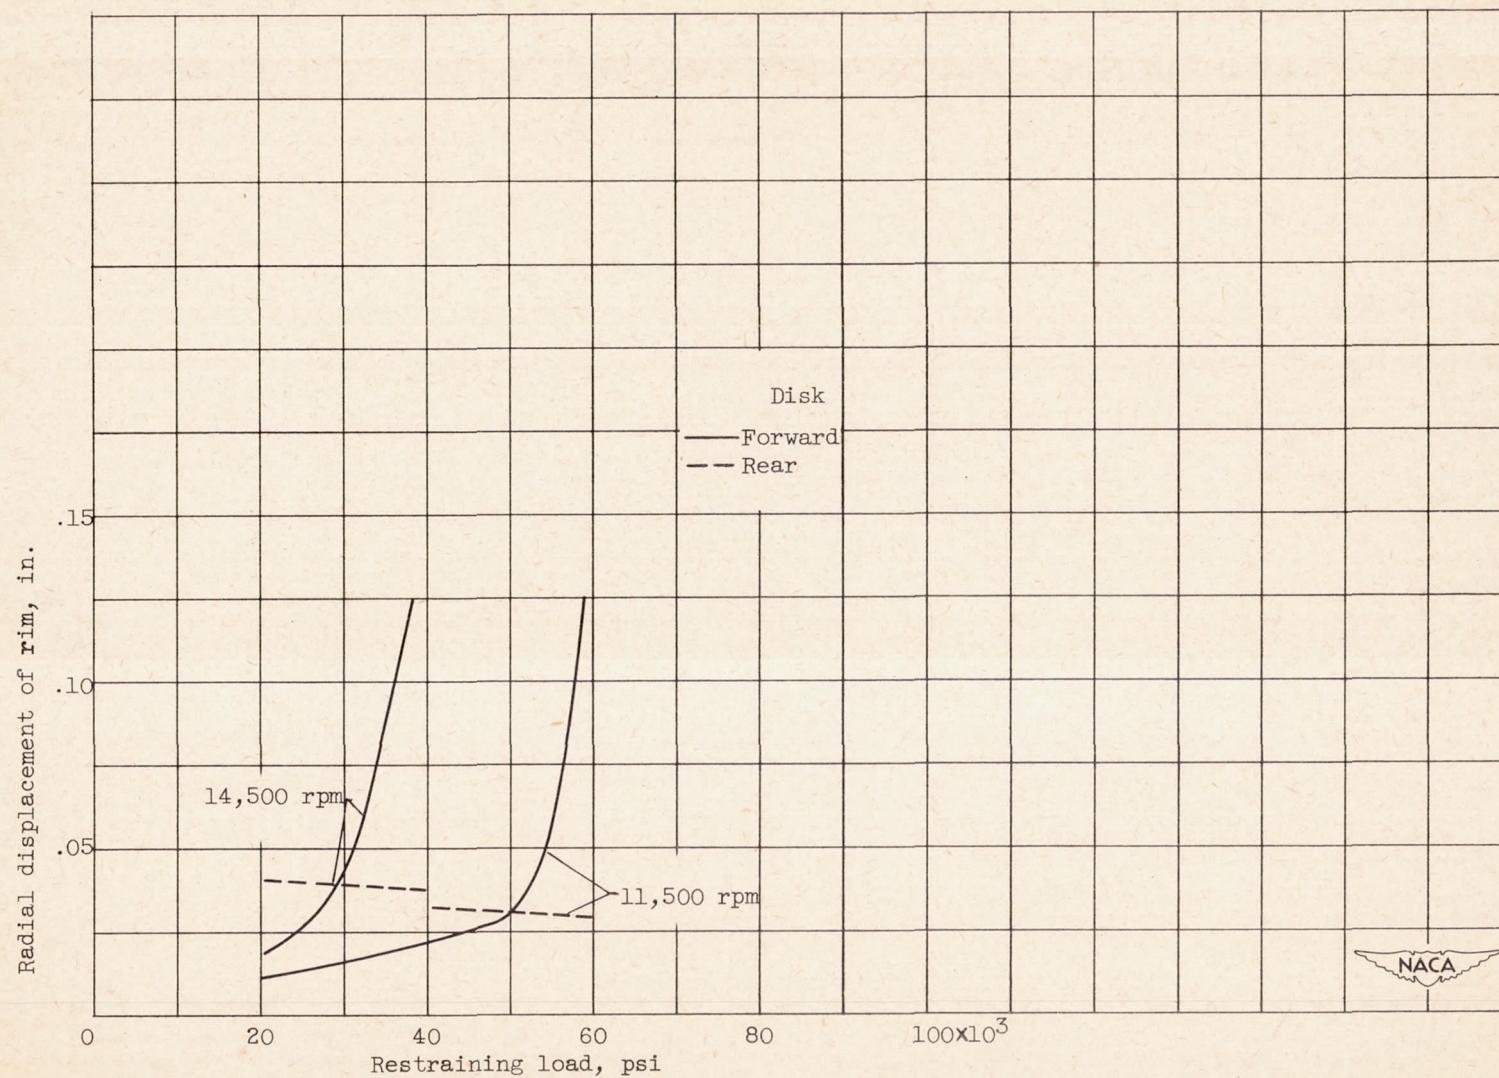
Plastic stress analysis at 11,500 and 14,500 rpm. - Because of plastic flow, the rim of the assembled rotor could no longer be assumed to seek a position at 11,500 rpm midway between the positions of the rims of the two disks treated as independent bodies. In order to obtain the total effective rim loading, it was necessary to employ a more elaborate procedure. Various values of restraining load were assumed and the total radial elongation of each disk was calculated for plastic flow for each assumed restraining load plus the normal rim loading. The elongation was plotted against restraining load for each disk and is shown in figure 17. Since it is assumed that the radial elongations of the two disks must be equal because of the connection at the rim, the restraining load is determined by the point at which the elongation curves intersect. The restraining load at the speed of 11,500 rpm is 50,000 pounds per square inch (fig. 17). The total effective rim loading on the forward disk is then 21,660 plus 50,000 or 71,660 pounds per square inch and the total effective rim loading on the rear disk is 21,660 minus 50,000 or -28,340 pounds per square inch.

Figure 17. - Graphical determination of restraining loads at 11,500 and 14,500 rpm.

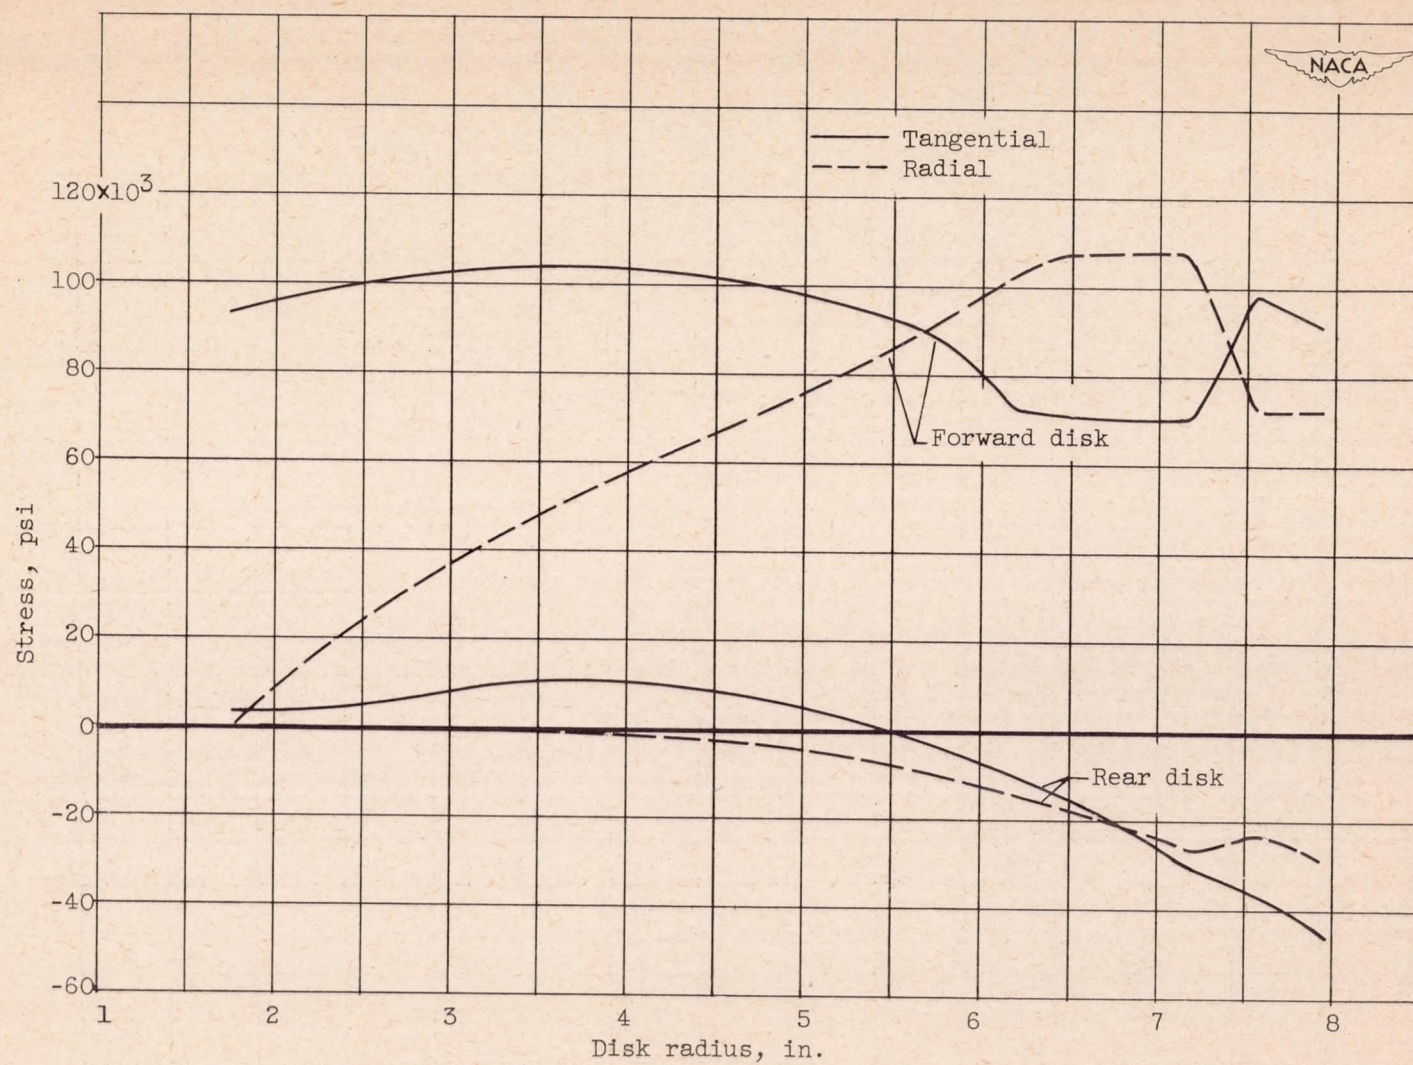
By utilization of the computed total effective rim loadings, the tangential and radial stresses were calculated for plastic flow and the data shown in figure 18. The stresses in the forward disk are considerably lower as a result of the plastic flow than in the analysis in which complete elasticity was assumed. In order to obtain some indication of the imminence of rotor failure, another plastic analysis was made at a speed of 14,500 rpm in the same manner as that described for 11,500 rpm. The elongation versus restraining load curves are shown in figure 17. At 14,500 rpm the elongations of the two disks are equal at a restraining load of 29,000 pounds per square inch. The total effective rim loadings are therefore 34,430 pounds per square inch (rim loading caused

Figure 18. - Plastic stresses for forward and rear disks having dissimilar temperature distributions at 11,500 rpm.

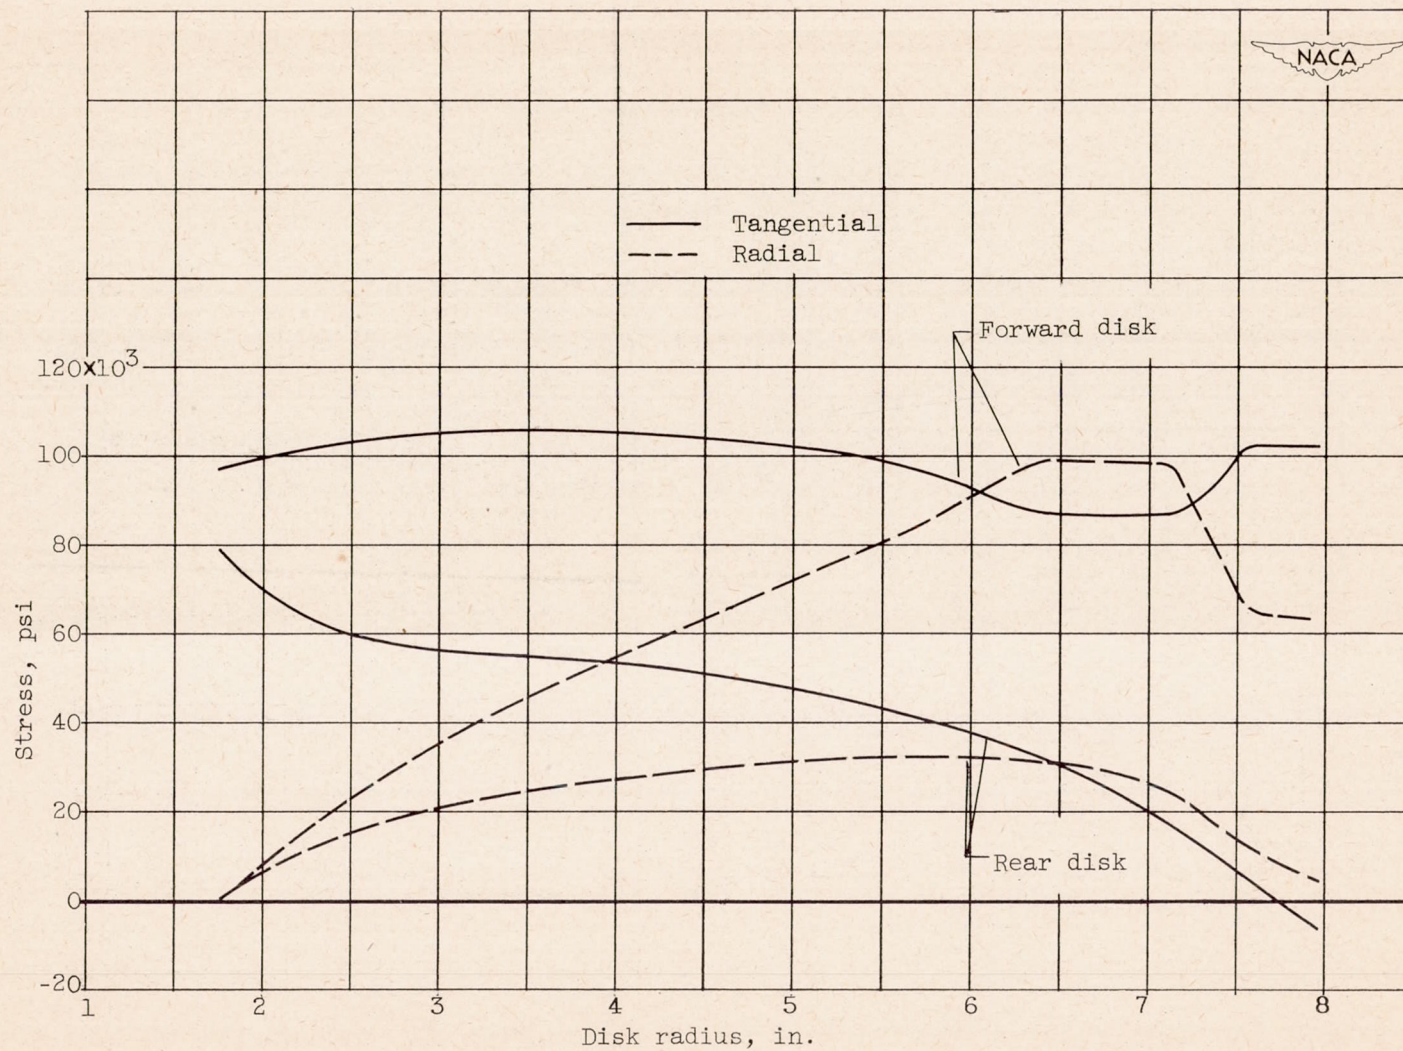
by blades and interrupted portion of disks) plus 29,000 pounds per square inch or 63,430 pounds per square inch for the forward disk and 34,430 minus 29,000 or 5,430 pounds per square inch for the rear disk. By utilizing these computed effective rim loadings, the stresses were again calculated for plastic flow and are shown in figure 19. A comparison of the results at 14,500 rpm with those of figure 18 for 11,500 rpm shows that the increase of 3000 rpm produced only a small change in the stresses in the forward disk but substantially increased the stresses in the rear disk. The processes involved are therefore evident. At the lower speeds of rotation, the high restraining loadings that result from the differential thermal expansions produce high tensile stresses in the forward disk and very low or compressive stresses in the rear disk. As rotative speed is increased, the stresses in the forward disk exceed the elastic limit of the material, resulting in plastic flow. This plastic flow, as shown in figure 17 reduces the restraining load and increases the effective rim loading on the rear disk while decreasing the effective rim loading on the forward disk. The stresses in the forward disk change only a small amount as a result of the combination of reduced restraining loading and increased speed while the stresses in the rear disk increase rapidly. A certain speed is reached at which the plastic flow decreases the restraining load to zero and both disks then attain the same stress levels. Although the forward disk attains a high stress level at operating speeds, the condition is not necessarily hazardous since a small amount of plastic flow in effect unloads the forward disk and causes the rear disk to assume more of the rim loading.

Figure 19. - Plastic stresses for forward and rear disks having dissimilar temperature distributions at 14,500 rpm.
